**GeoResources, LLC**  
5007 Pacific Hwy. E., Ste. 16  
Fife, Washington 98424-2648

December 7, 2010

Geologic Reconnaissance Letter  
Water Tank Site  
xxx Artondale Drive NW  
Pierce County, Washington  
PN: 4991320350  
Job: KREWD.ArtondaleDr.GR

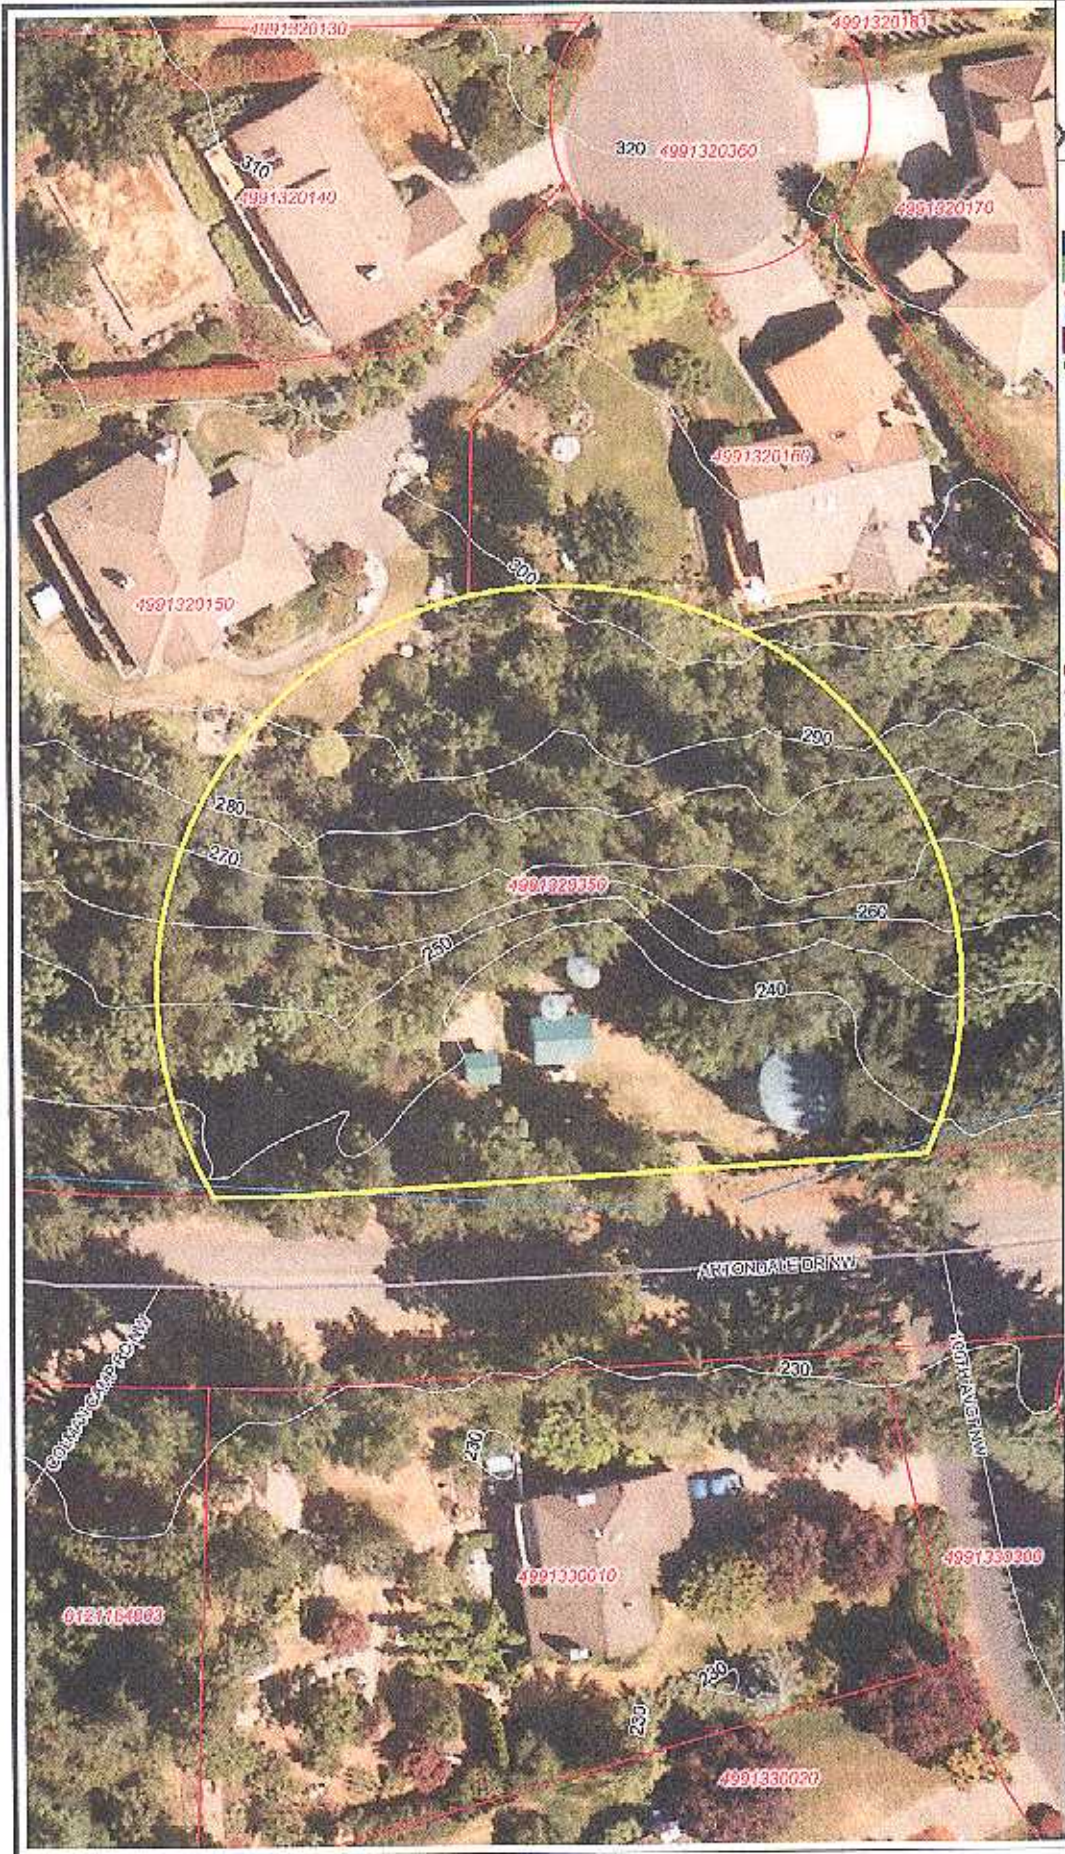
Figure 2

The site is located on the western margin on the Kopachuck Ridge glacial upland area. From Artondale Drive, the site is generally flat to gently sloping up. North of the existing water tanks is a short two-tier ecology block wall. The site slopes up from the block walls at inclinations between 50 and 100 percent, with up to 45 feet of vertical relief. From the top of the slope, grades flatten out to about 25 to 30 percent, and extend up to the existing residences to the north. Total topographic relief across the water tank parcel is on the order

of 50 feet, while total relief from Artondale Road up to the neighboring residences is on the order of 60 to 75 feet. An aerial photograph with topography was contour was obtained from the Pierce County CountyView GIS and is attached as Figure 2.

During our August 20, 2010 site visit, we explored subsurface conditions by excavating three shallow hand borings. The hand borings were excavated by using a 3-inch diameter hand auger and posthole digger. The hand borings were excavated to depths ranging from 3½ to 5½ feet below existing ground surface. No groundwater seepage was observed in our hand borings at the time of digging. The approximate locations of the hand augers are shown on the attached Site Plan, Figure 2.
