**GeoResources, LLC**  
5007 Pacific Hwy. E., Ste. 16  
Fife, Washington 98424-2648

December 7, 2010

Geologic Reconnaissance Letter  
Water Tank Site  
xxx Artondale Drive NW  
Pierce County, Washington  
PN: 4991320350  
Job: KREWD.ArtondaleDr.GR

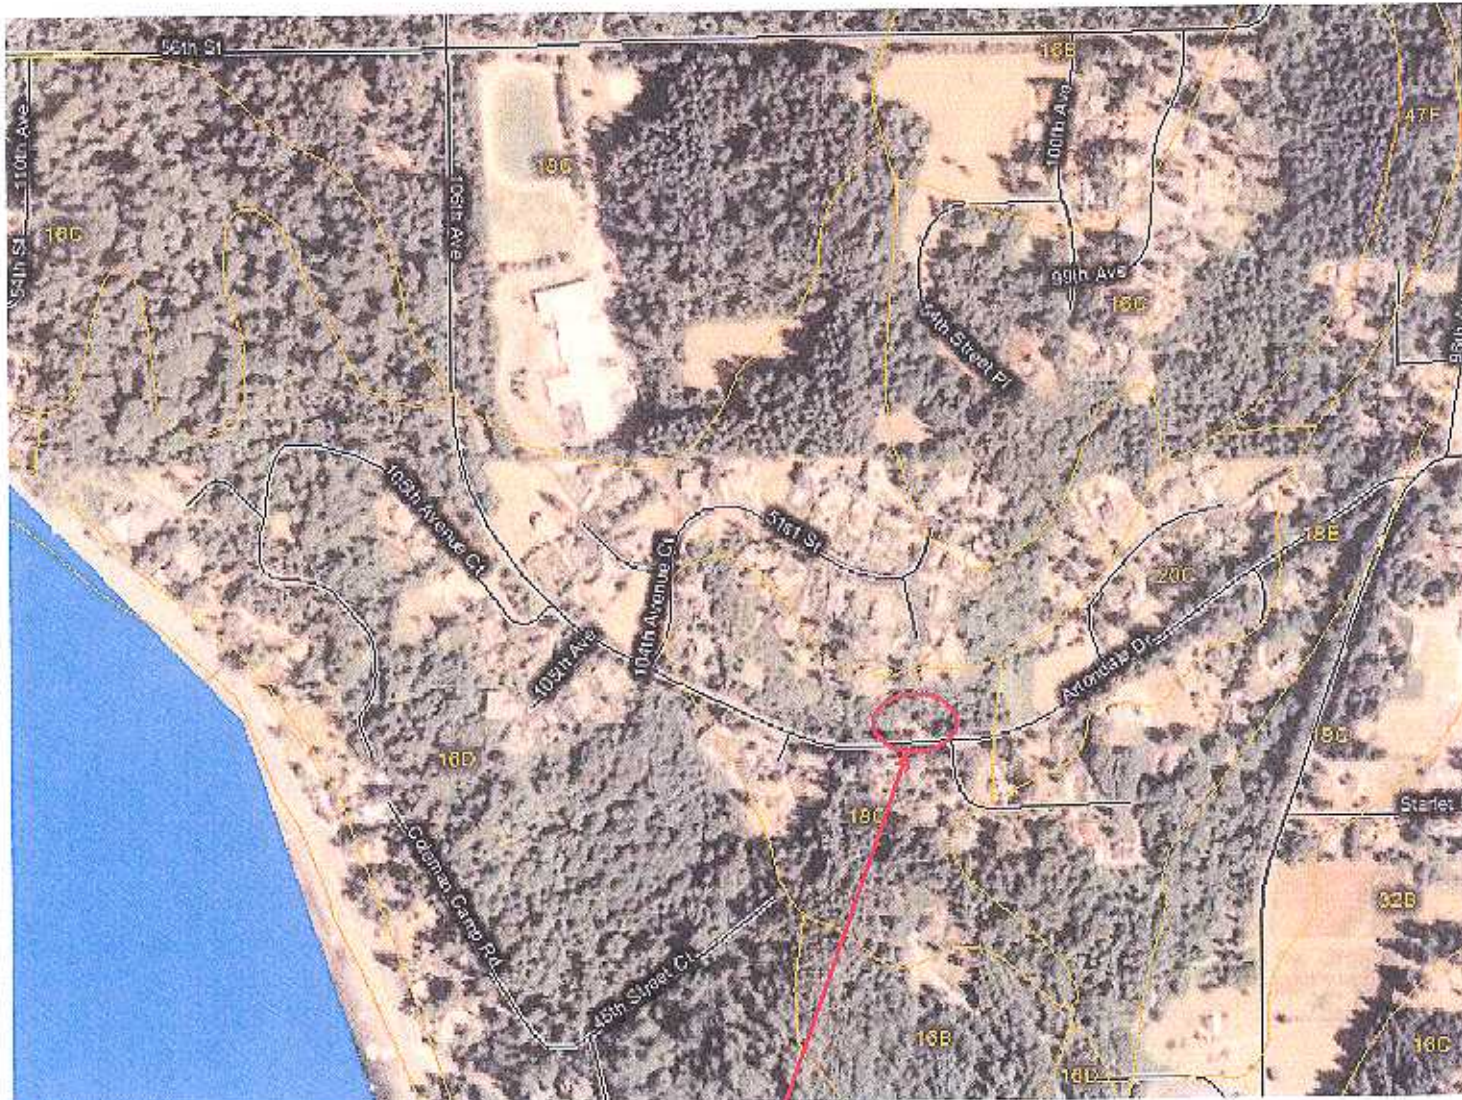
Figure 3

The USDA Natural Resource Conservation Service (NRCS) Web Soil Survey for Pierce County maps the soils in the area of the site as Indianola loamy sand (18C). The Indianola soils are derived from sandy outwash deposits that form on 6 to 15 percent slopes and are listed as having a "moderate" erosion hazard. Because of the steepness of the slopes, and given the observed near surface soil conditions, we would interpret the site soils to be more representative of the 18E soils, which form on slopes of 15 to 45 percent, and have a "moderate to severe" erosion hazard. A copy of the SCS map for the site vicinity is attached as Figure 3.

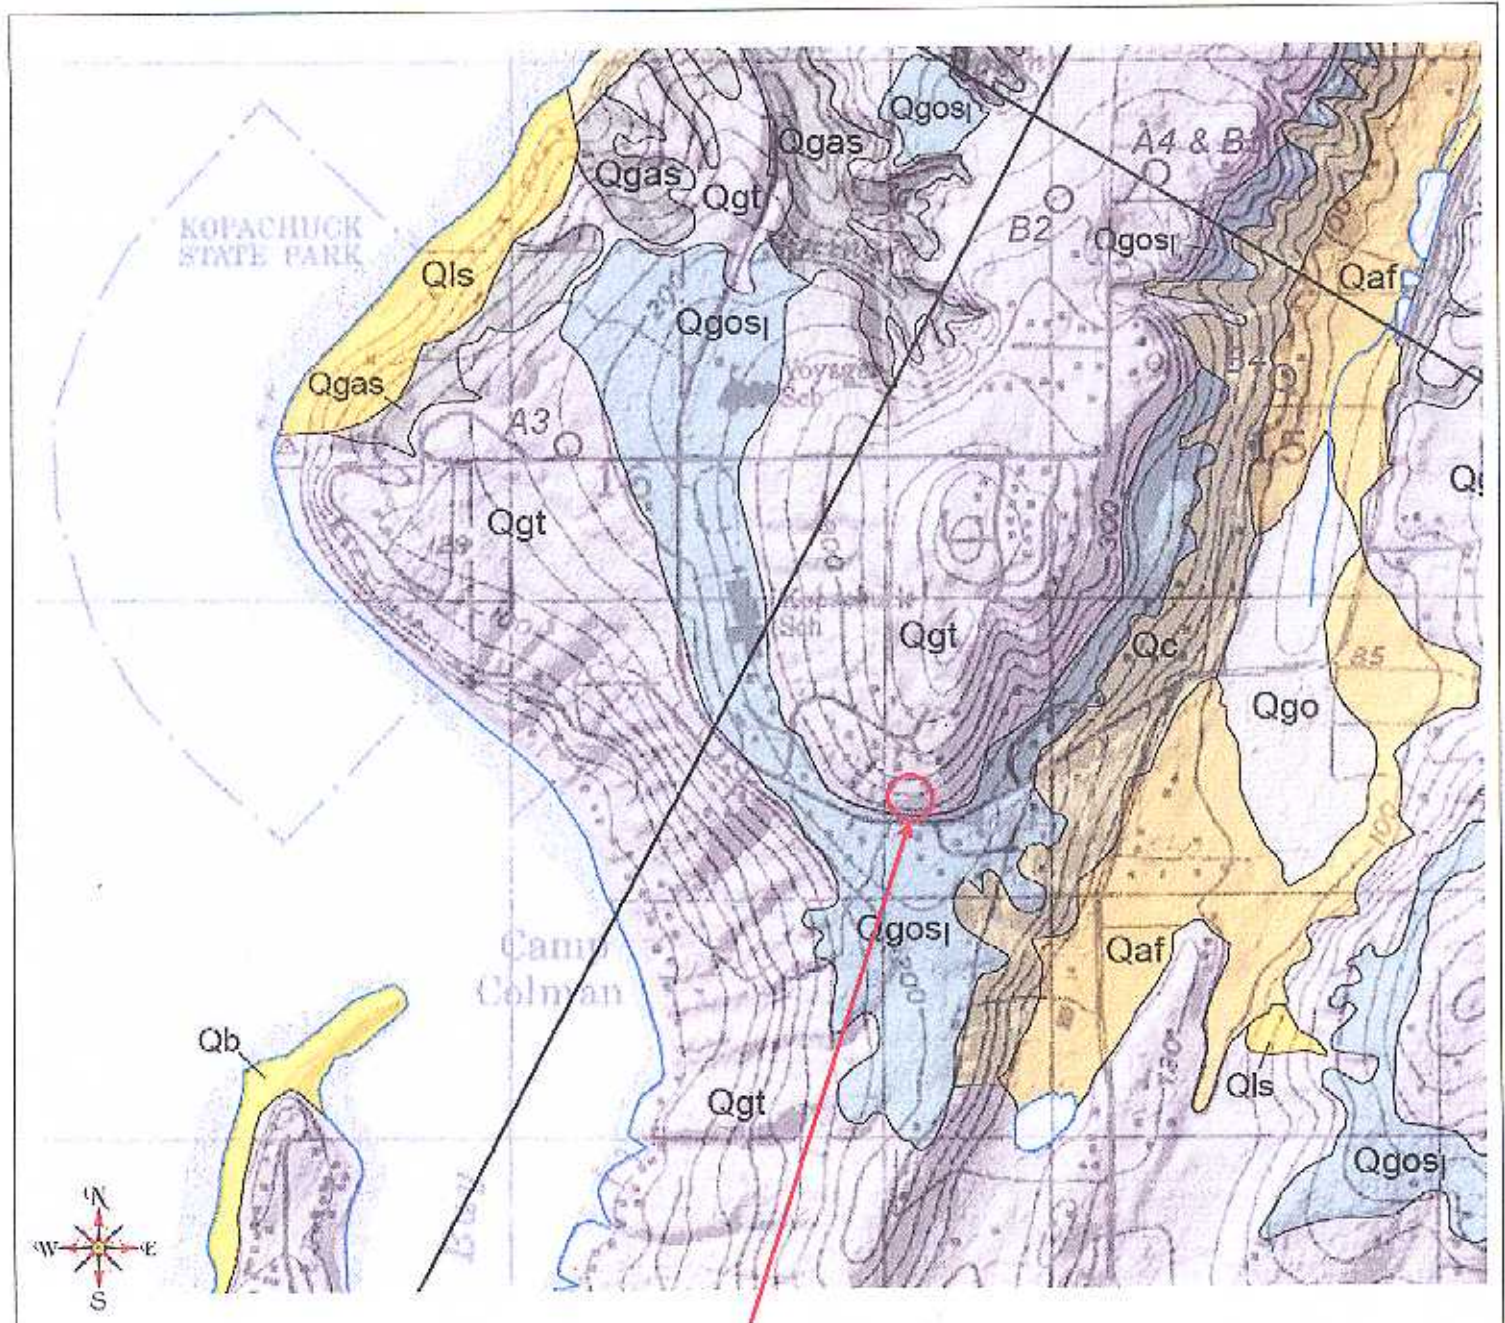
**USGS Geologic Map**  
 XXX Artondale Drive NW  
 Pierce County, Washington

The *Geologic Map of the Fox Island 7.5 minute Quadrangle, Pierce County, Washington* by Logan, Walsh, and Troost (2006), indicates the site underlain by glacial till (Qgt). These glacial soils were deposited during the most recent Vashon Stade of the Fraser Glaciation, approximately 12,000 to 15,000 years ago. The glacial till consists of a heterogeneous mixture of clay, silt, sand, and gravel that was deposited at the base of the prehistoric continental glacial ice mass and was subsequently over-ridden. As such, the glacial till is considered overconsolidated and exhibits high strength and low compressibility characteristics. The glacial till is typically overlain by a thin, intermittent veneer of recessional outwash and underlain by advance outwash. Outwash consists of poorly sorted mixtures of sand and gravel that were deposited by the receding and advancing ice mass, respectively. Like the till, the advance outwash was overridden by the prehistoric ice sheet and is considered over-consolidated, while the recessional outwash was not overridden and is considered normally consolidated. No areas of erosion, mass wasting, or landslides are indicated on the geologic map in the general site area. An excerpt of the above referenced map is included as Figure 4.

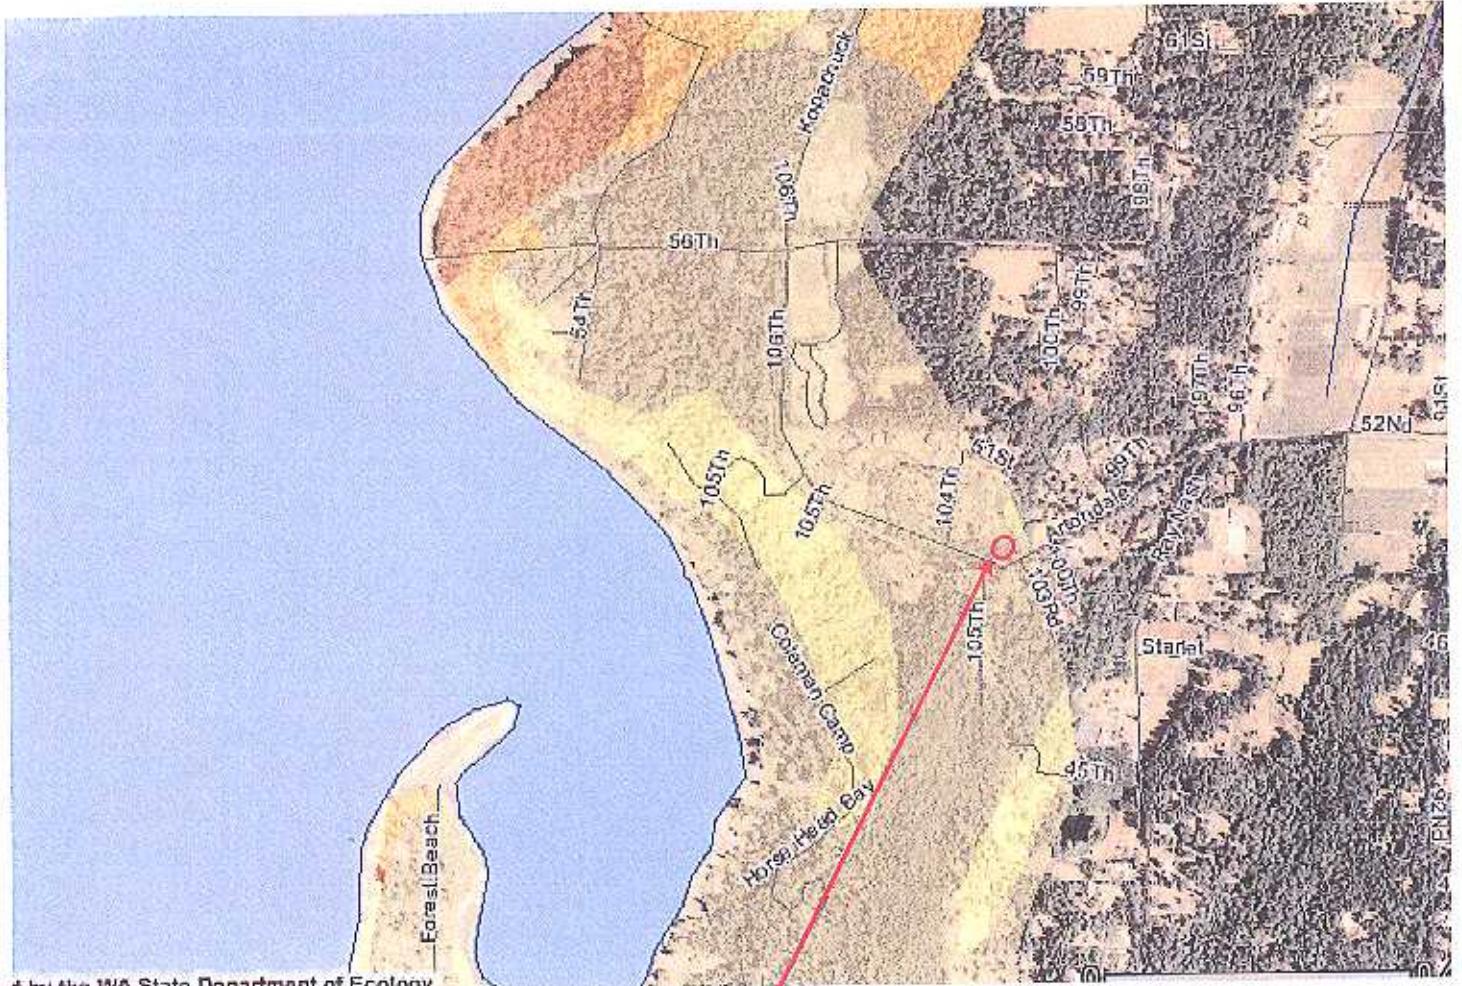
The Coastal Zone Atlas for Pierce County indicates the area around the site as "S" for stable. A copy of the Coastal Zone Atlas is included as Figure 5. No areas of landslides ("Uos" or "Urs") are located within 300 feet of the parcel as mapped by the Coastal Zone Atlas.
